MEMORANDUM FOR MICHAEL DAVIS

SUBJECT: Field Investigation at the U.S. Department of Energy's Waste Isolation Pilot Plant (WIPP), ID No. 29-01857, Carlsbad, New Mexico (RCD Control Number 17AA01)

Executive Summary

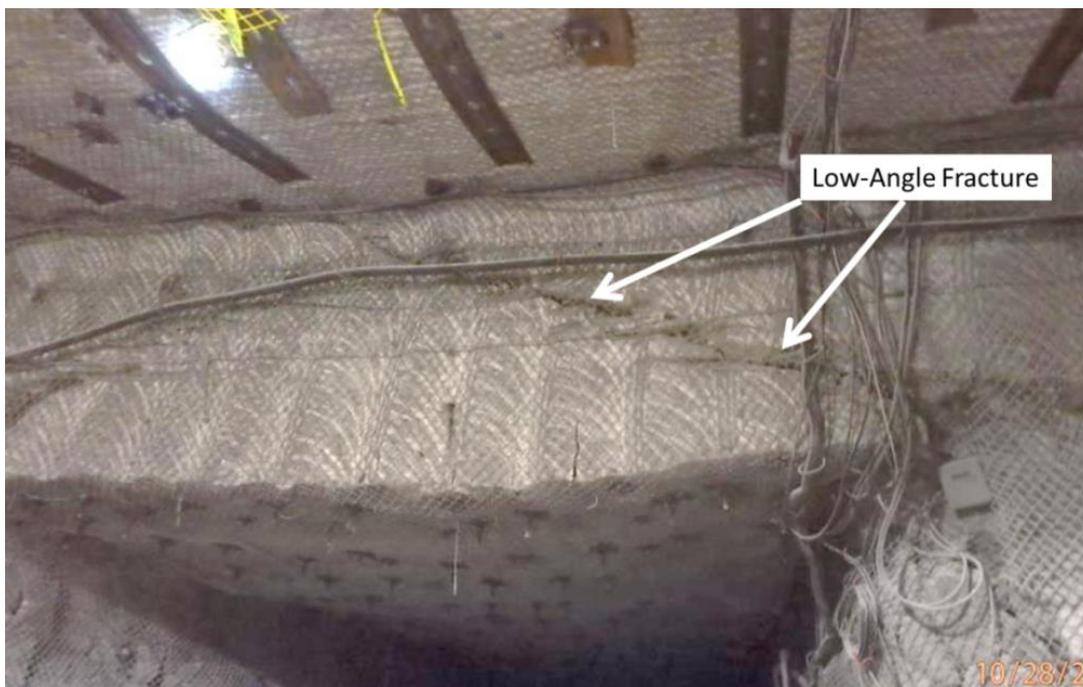
The continuing creep causes “low-angle fractures” to develop in the roof beam (see Figures 3 and 4). These fractures generally begin at the roof line near the ribs and terminate at the clay seam. Eventually the low-angle fractures will coalesce on one side or the other, creating a cantilevered roof beam with a relatively sharp “point” on one end. Once the fractures have coalesced, the beam is free to slide along the clay layer, and the displacement rates accelerate. As the free end of the beam is forced downwards, tensile fractures develop at the top of the beam at its other end, and large gaps develop between the beam and the overlying salt. Unless controlled by heavy roof support, gravity will take over and a roof collapse will ensue. If the beam is supported, it will continue to compress laterally and become severely deformed. Roof bellies of 4 feet or more can develop, accompanied by extensive fracturing and separations (Figure 5).

FIGURE 4.—Photograph showing a low-angle fracture exposed in a roof brow.

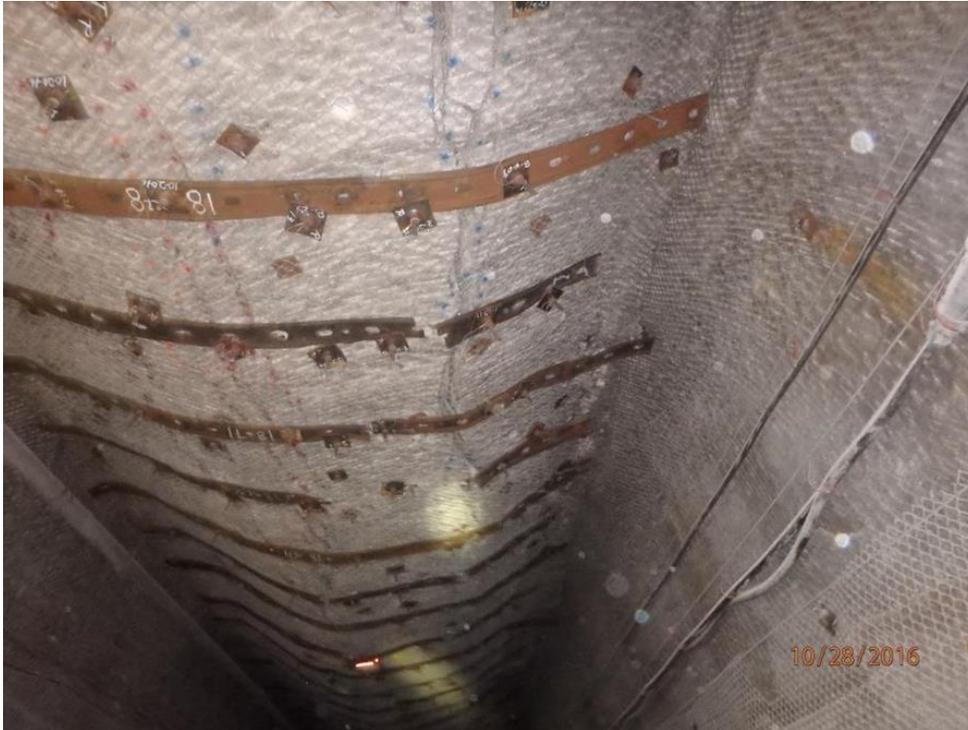
FIGURE 5.—Severe roof bulging in a WIPP drift supported by long tendons, short bolts, straps, and mesh.

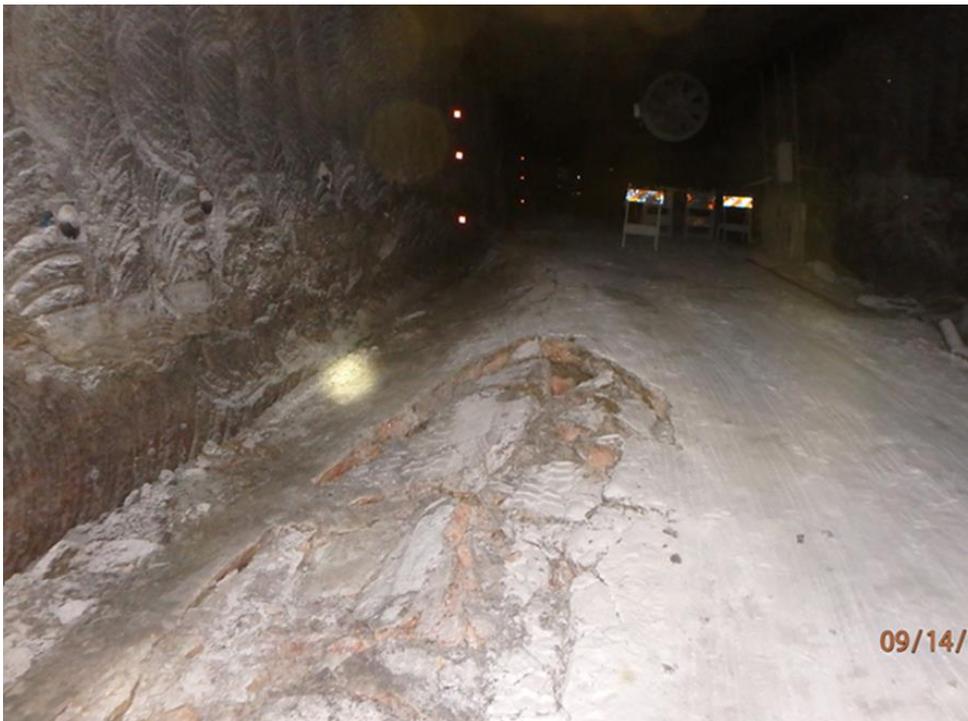
Floor heave, which has more impact on equipment travel than it does on safety, can follow a process that is analogous to roof failure (Figure 6). A floor beam can develop with extensive uplift into the opening. Pillar creep can also cause extensive fracturing in the ribs (Figure 7).

FIGURE 6.—Floor heave in WIPP drift.

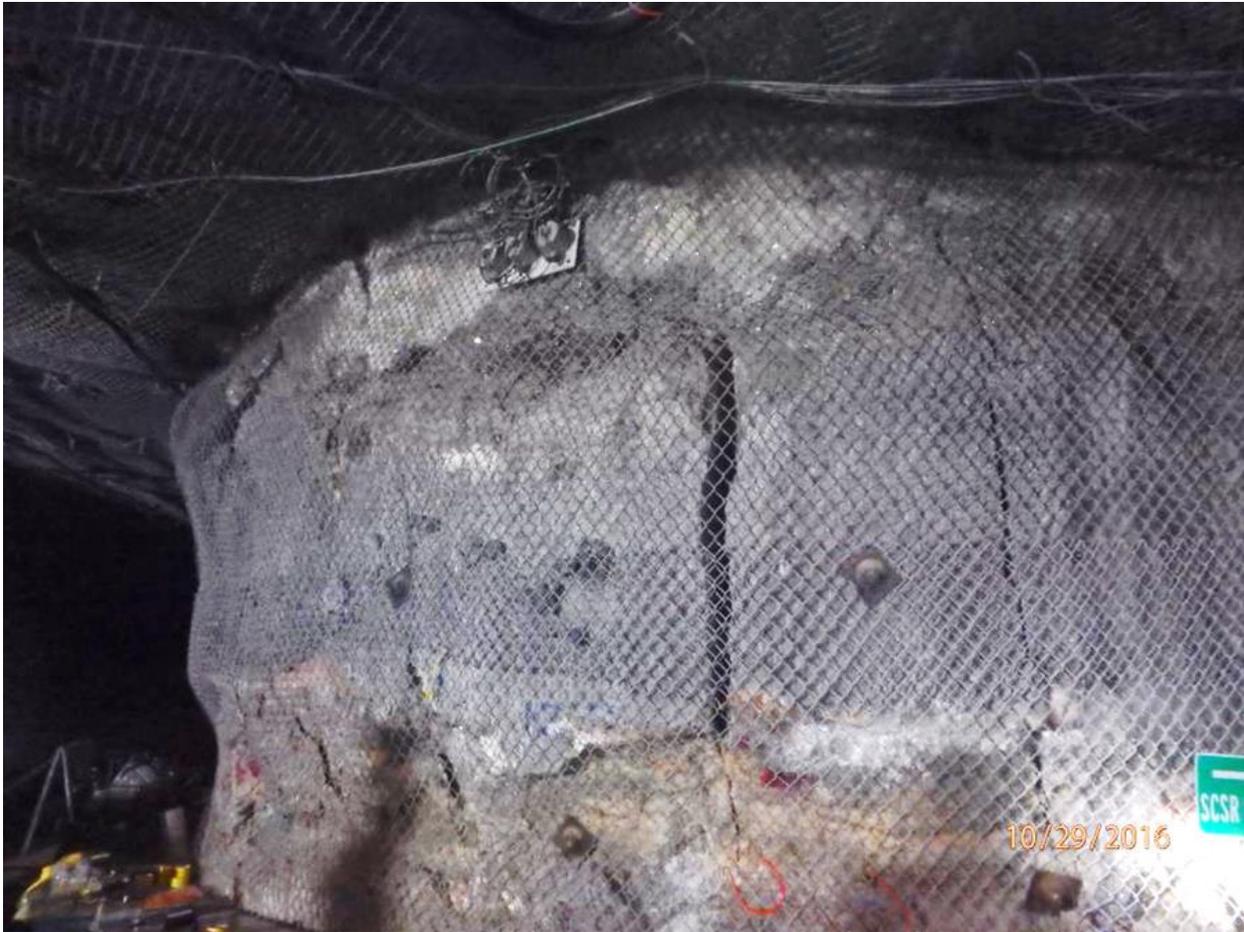
FIGURE 7.—Rib fractures contained by short bolts and mesh.

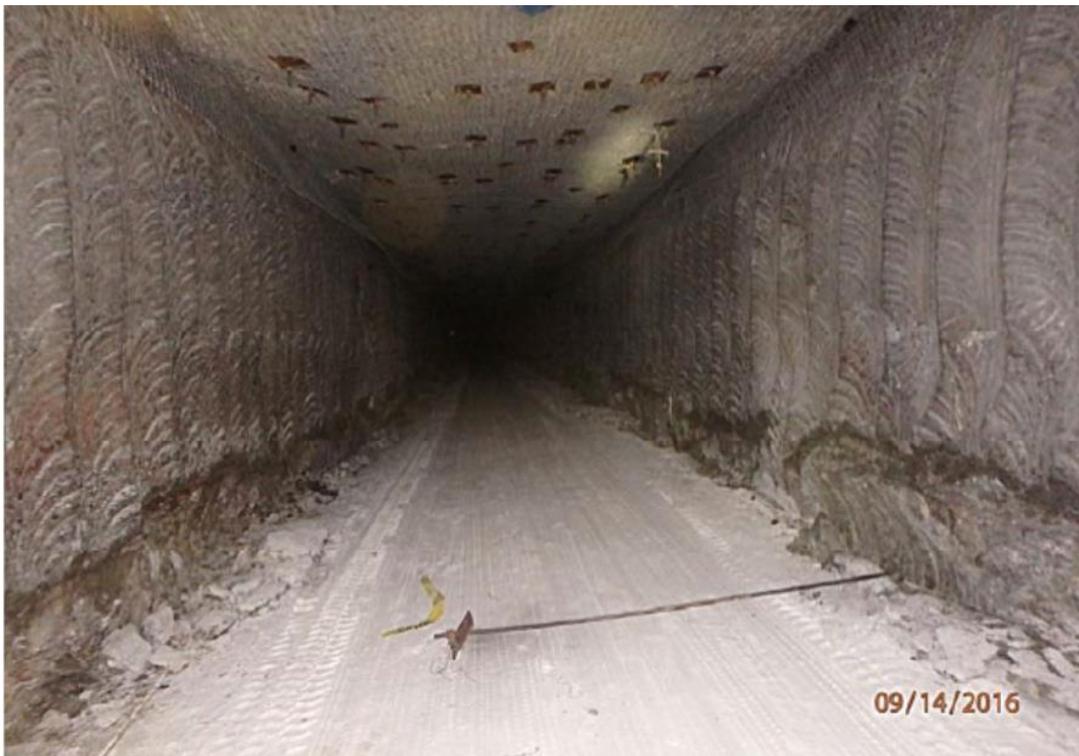
As ground control maintenance operations fell behind, roof conditions deteriorated throughout the facility. MSHA resumed regular inspections of WIPP in September 2014 and ground conditions have been cited 34 times since then.⁴ Six of these citations have addressed hazardous roof conditions, and three more addressed rib conditions. The other 25 citations have been for broken, hanging, and unsecured roof bolts and plates that could fall and injure personnel (see Figure 9). In the past, a man lift was routinely used to secure bolts and remove broken ones, but the recent ventilation restrictions have reportedly precluded its use.

FIGURE 9.—A broken roof bolt that has fallen to floor.
