MEMORANDUM FOR MICHAEL DAVIS

SUBJECT: Field Investigation at the U.S. Department of Energy's Waste Isolation Pilot Plant (WIPP), ID No. 29-01857, Carlsbad, New Mexico (RCD Control Number 17AA01)

Executive Summary

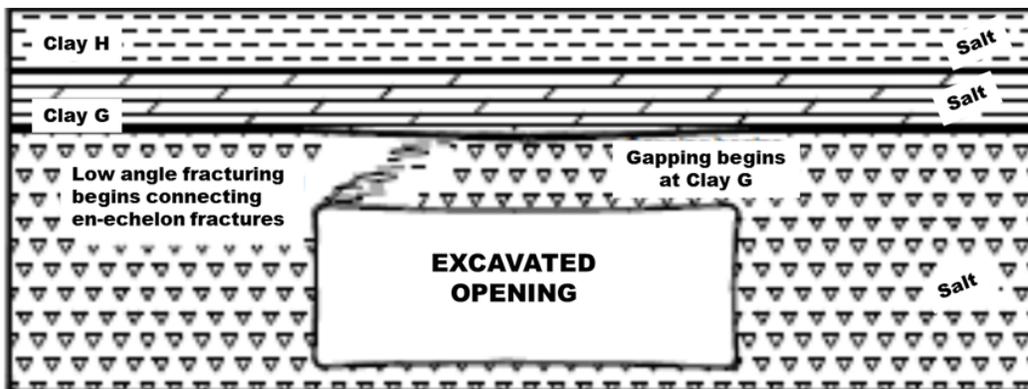
The continuing creep causes “low-angle fractures” to develop in the roof beam (see Figures 3 and 4). These fractures generally begin at the roof line near the ribs and terminate at the clay seam. Eventually the low-angle fractures will coalesce on one side or the other, creating a cantilevered roof beam with a relatively sharp “point” on one end. Once the fractures have coalesced, the beam is free to slide along the clay layer, and the displacement rates accelerate. As the free end of the beam is forced downwards, tensile fractures develop at the top of the beam at its other end, and large gaps develop between the beam and the overlying salt. Unless controlled by heavy roof support, gravity will take over and a roof collapse will ensue. If the beam is supported, it will continue to compress laterally and become severely deformed. Roof bellies of 4 feet or more can develop, accompanied by extensive fracturing and separations (Figure 5).

FIGURE 3.—Formation of a low-angle fracture due to creep in a typical drift at WIPP.

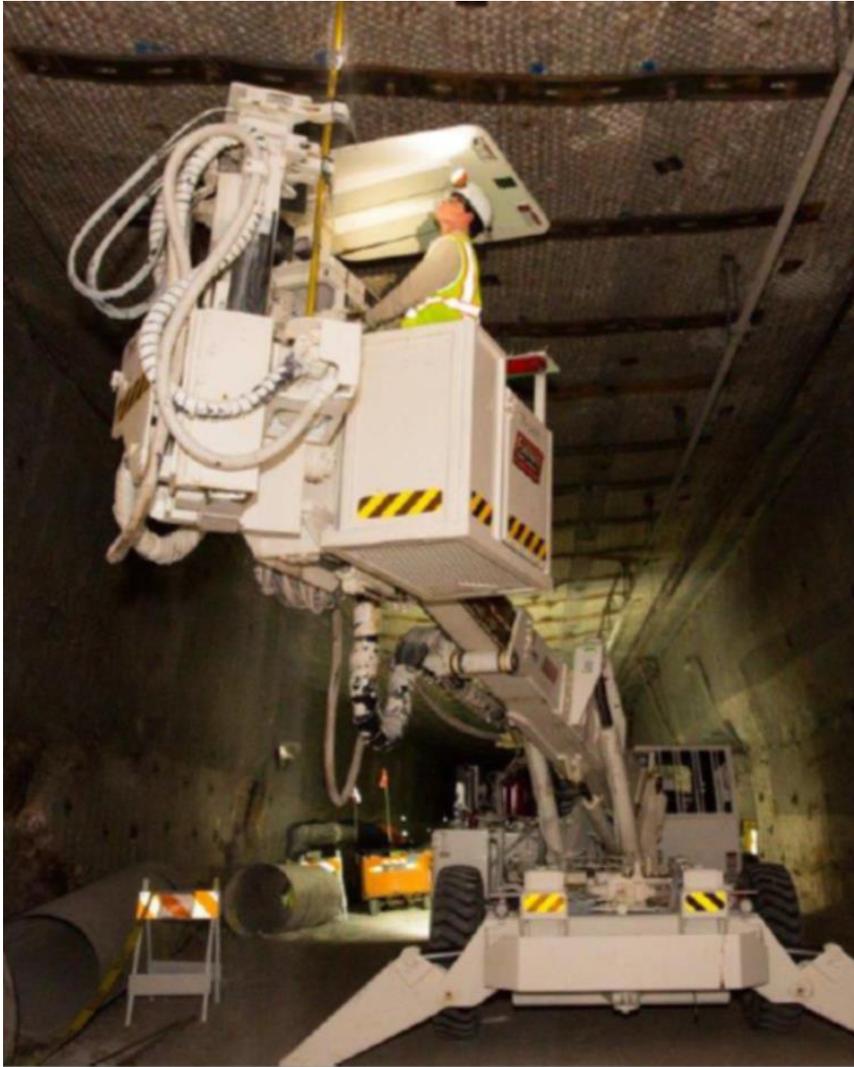
Roof support is installed using diesel or “hybrid” diesel-electric single-boom roof bolting machines. Figure 8 shows that the roof bolt operator is protected by a canopy, but there is no automated temporary roof support (ATRS) like those required on roof bolting machines used in coal mines. The lack of an ATRS means that a roof bolt operator at WIPP has less protection from loose rock. However, an ATRS would be difficult to retrofit because of the greater height

of the drifts at WIPP compared with coal mines. In addition, an ATRS might fracture and destabilize a thin, detached layer if too much pressure was applied. So long as mesh is installed on the roof before fracturing develops, roof bolt operators should be protected from loose rock during subsequent rebolting operations.

FIGURE 8.—A roof bolting machine at WIPP.
