Figure 1. Map of the Pajarito Fault System and Embudo Fault System – Southwestern Section in Northern New Mexico. **Source:** Figure 5-4 in LANL 2007 PSHA Report.

Figure 2. Mapped Faults in the Los Alamos National Laboratory Area.

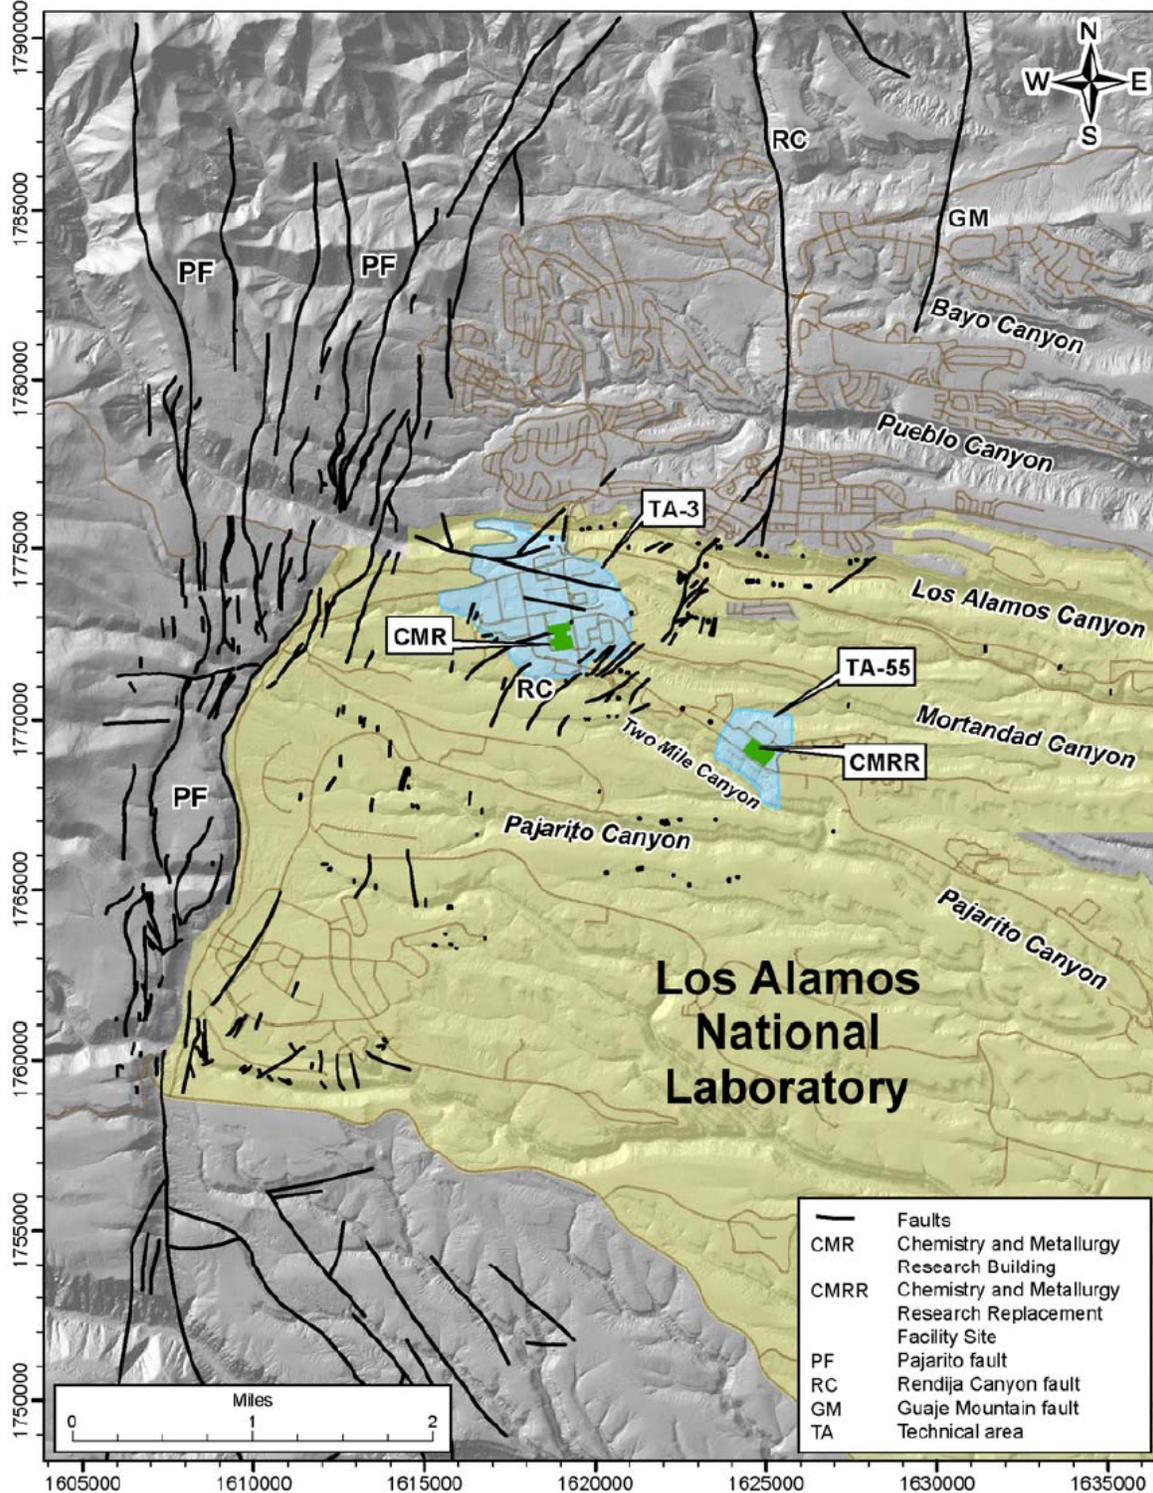
Please Note. The detailed mapping to determine the southward extent of the GM Fault (Guaje Mountain Fault) toward and possibly close to the location of the proposed CMRR Nuclear Weapons Facility has not been performed.

Source: Figure 3-5 in the DOE 2011 SEIS

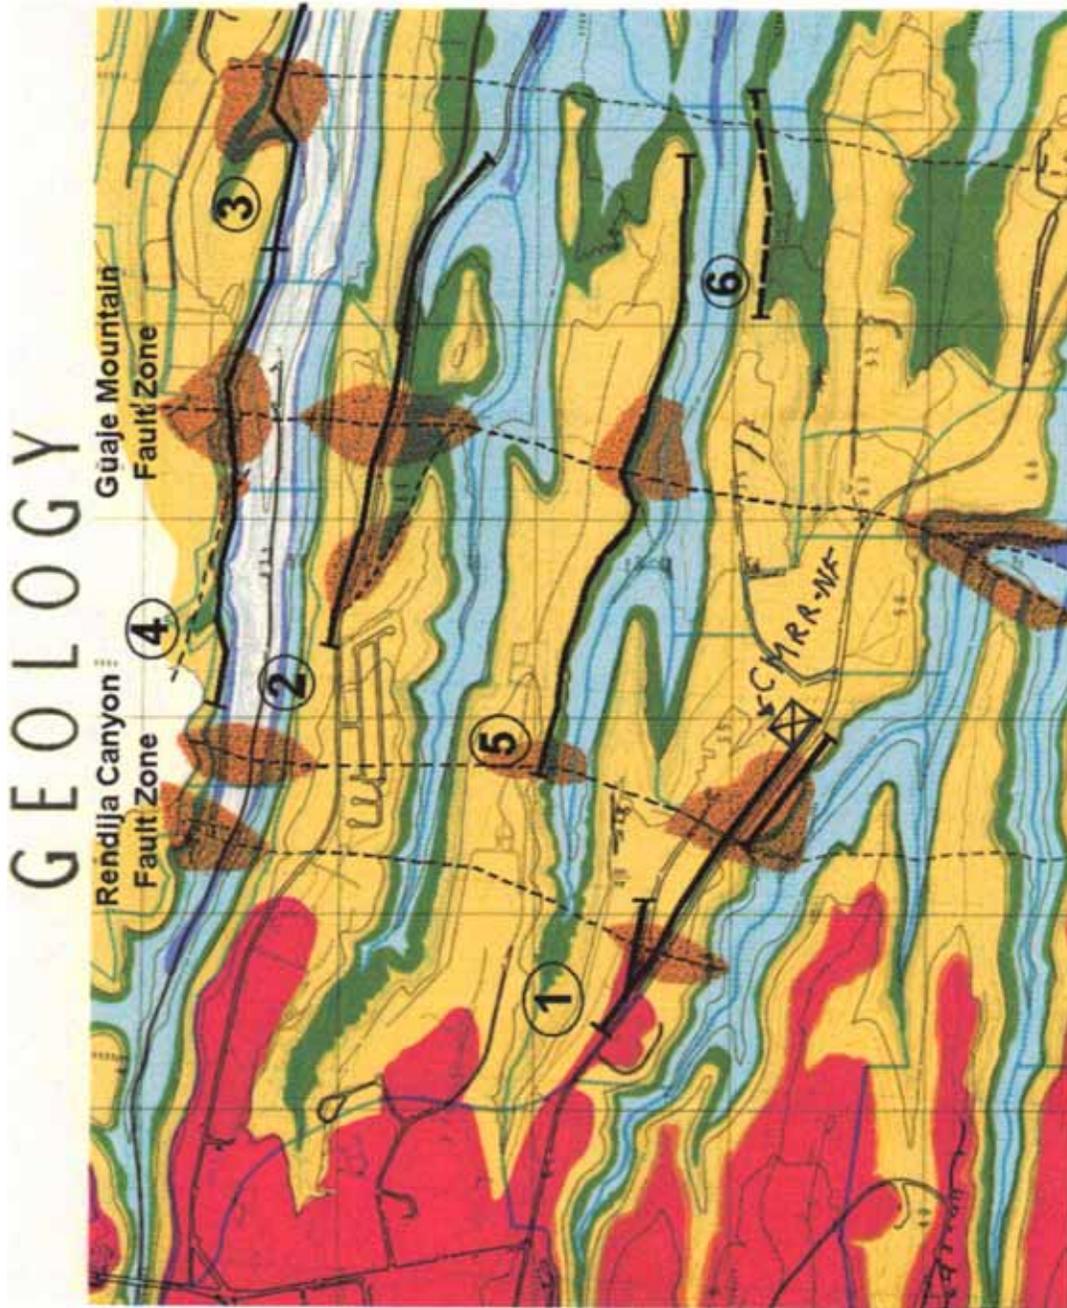
Figure 3. Map in 2004 LANL Report by Wohletz showing proposed location of Rendija Canyon Fault along the western boundary of LANL TA-55 and Guaje Mountain Fault 2500 feet east of the eastern boundary of TA-55.
Source: Figure 14 in Wohletz, 2004 (LA-UR-04-8337)

Scale 0-----1950 feet

- Black X inside rectangle is location of proposed CMRR-NF
- Dashed black lines show trend of inferred faults - - - - -
- Brown patches along dashed black lines are zones of intense fractures
- Circled numbers 1 to 6 have no relation to intense fracture zones.
